August Edition of Renewable Natural Gas Engine Tech Talk

Service Bulletin Number: 5659915

Closed Crankcase Ventilation System Engine Lubricating Oil Carryover and Associated Turbocharger Lubricating Oil Leak

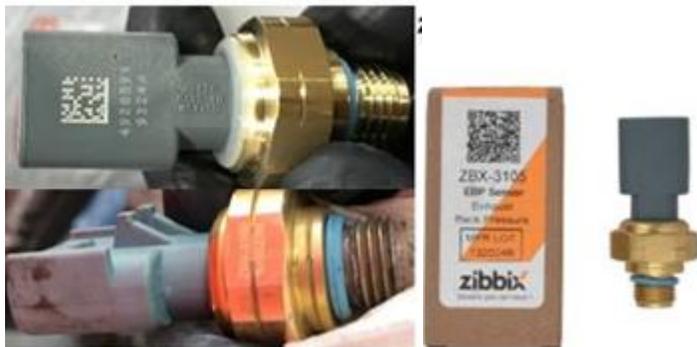
Engineering has recently investigated several customer reports of engine misfire fault lamps events. After lengthy investigations, the aftermarket replacement sensor installed has been determined to be the root cause for this unscheduled service event. Faulty sensors will lead to misfire fault codes that result in a catalyst protection event or engine power reduction mode even though the engine was otherwise running fine. Please be advised, using non Cummins components replacement parts can and often do result in poor engine performance and efficiency.

Solution: **Genuine Cummins PN 4928594** is used on B6.7N, L9N, and ISX12N with Zibbix and Dorman aftermarket sensors. Non-genuine EMP sensor leading to erroneous misfire detection score increments. This can cause misfire catalyst protection derate even though the engine is otherwise running fine resulting in low power and CEL complaints.

It is recommended that aftermarket replacement parts are not used on natural gas applications. These items include spark plugs, sensors, etc.
